# Manhole Inspection Summary

Manhole # S23K1\_004MH

Insp Date: **11/25/08 2:25 PM**

**Location** Address: **2731 Marboune Ave.**

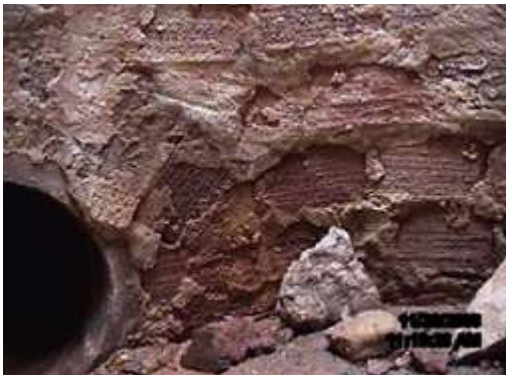
Defect 5

Infiltration: ☐ None ☐ Joint ☐ Cracks ☐ Mortar ☐ Roots ☒ **Wall**

barrel infiltration

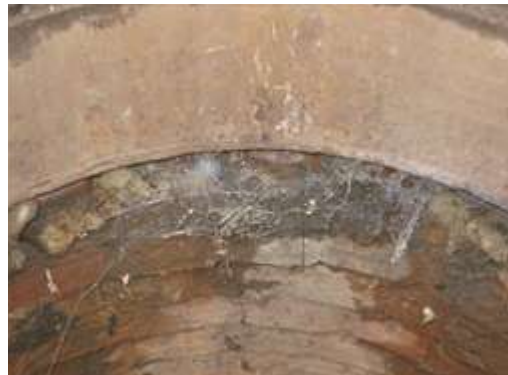
Defect 4

Condition: ☐ Sound ☐ Cracked ☐ Root Intrusion ☒ **Loose Brick** ☒ **Deteriorated**

Infiltration: ☐ None ☐ Joint ☐ Cracks ☒ **Mortar** ☐ Roots ☐ Wall

deteriorated chimney with infiltration

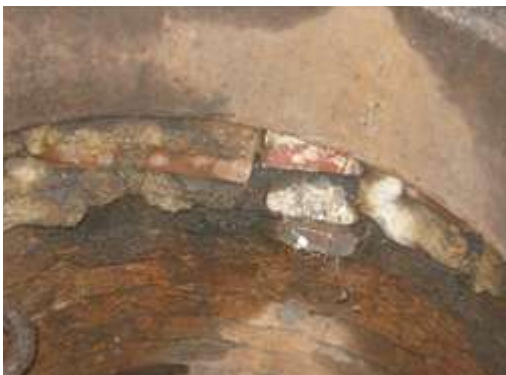
Defect 3

missing mortar at chimney with infiltration

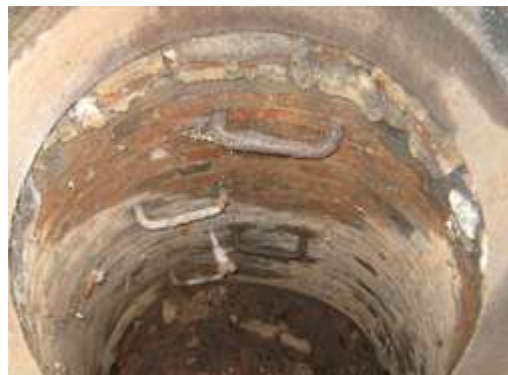
Defect 2

chimney and corbel infiltration

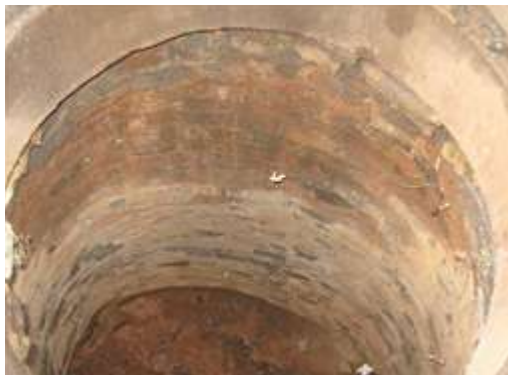
Defect 1

Infiltration: ☐ None ☐ Joint ☐ Cracks ☐ Mortar ☐ Roots ☒ **Wall**

corbel infiltration

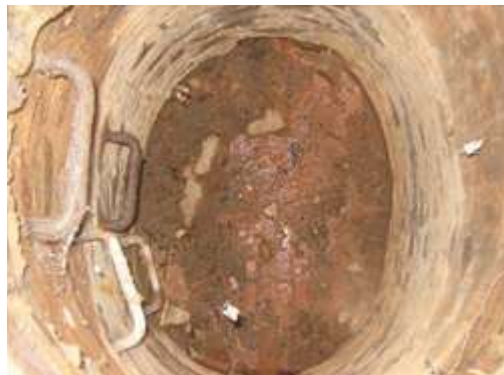
Defect

Condition: ☐ Sound ☐ Cracked ☐ Root Intrusion ☐ Deteriorated ☐ Leaks ☒ **Debris**

**Steps** Count: **4** Missing: **0** ☒ **Corroded**

Corroded Steps & channel debris
